# ANNUAL REPORT FOR 2010

**UT to Cold Water Creek Mitigation Site  
Cabarrus County  
TIP No. R-2533B (Site 23)**

Prepared By:  
Natural Environment Unit & Roadside Environmental Unit  
North Carolina Department of Transportation  
October 2010

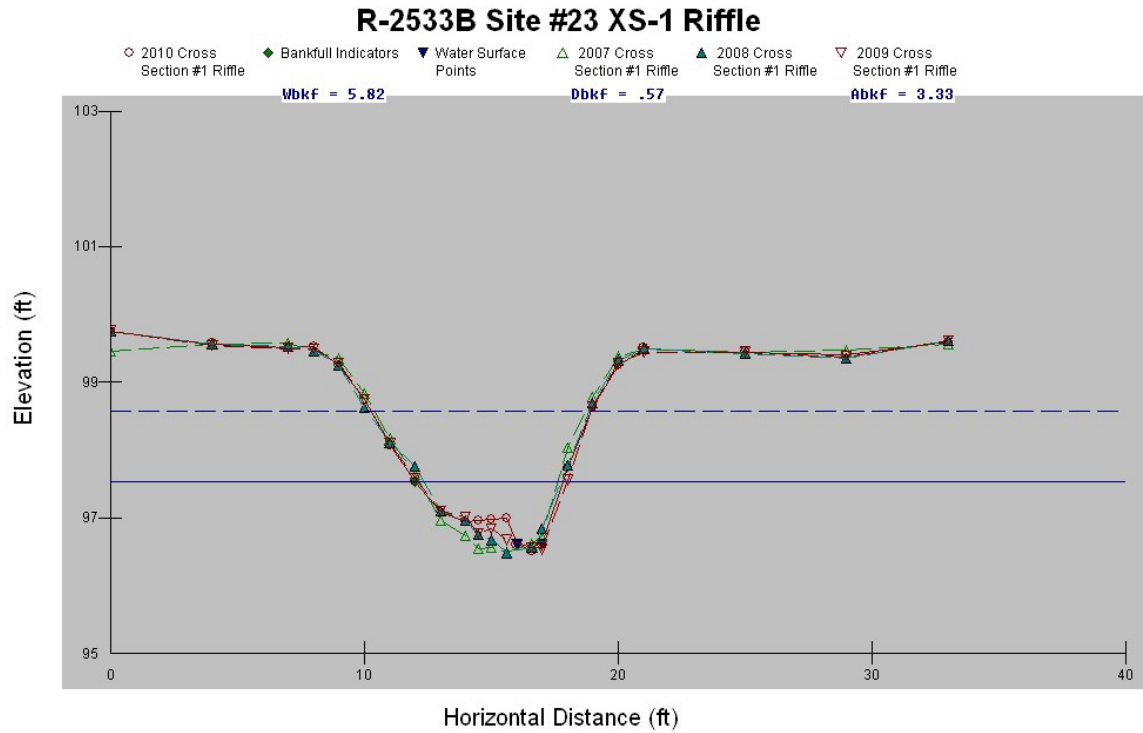
**Site #23: Cross-Section #1 (Riffle) Abbreviated Morphological Summary**

Based on comparisons of all the years of monitoring data, all of the cross sections appear stable with little or no active bank erosion. Graphs of the cross sections are presented in Appendix A. Future survey data will vary depending on actual location of rod placement and alignment; however, this information should remain similar in appearance. Pebble counts were not required per the permit conditions and therefore were not completed.
